**Item #4 – Economic
Development – Update
(Agenda Item)**

June Lake Cleanup

FY22 Summary

Mammoth Lakes Pilot Dives

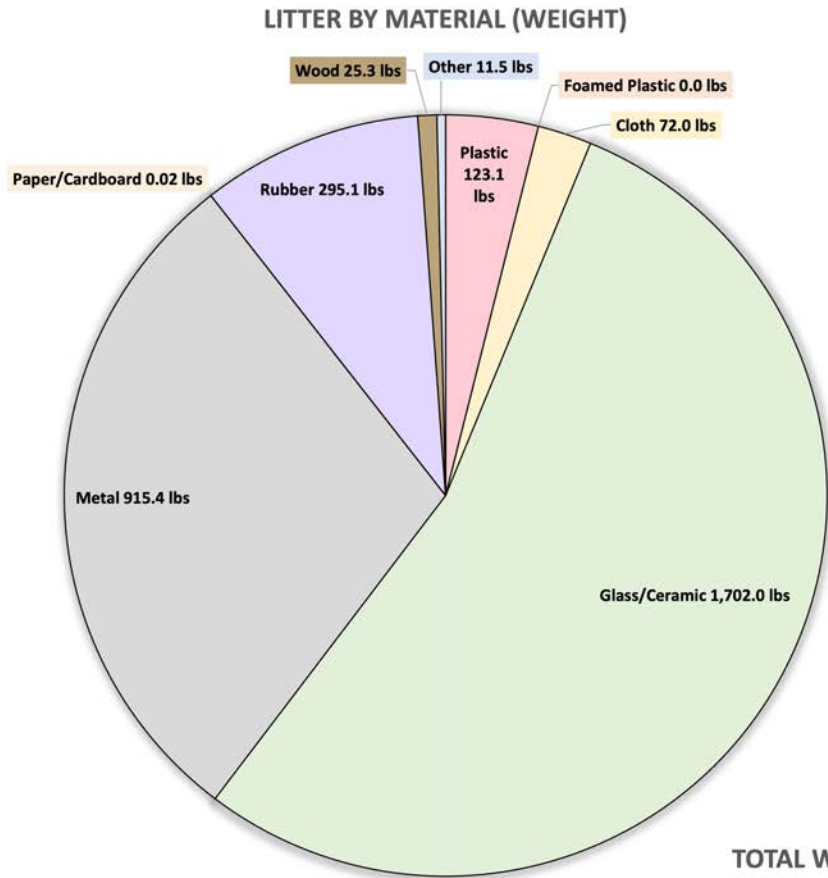
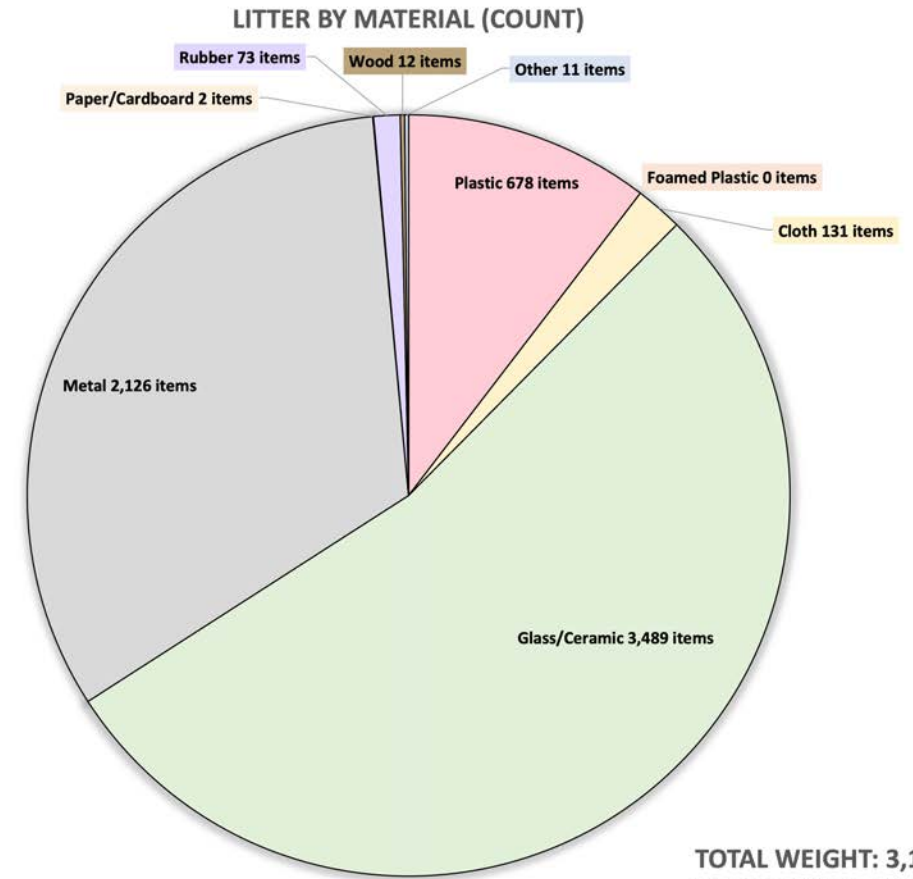
Litter Breakdown Visual Aid

Material Type	Total Weight (lbs)	Total Count (#)
Plastic	123.1	678
Foam Plastic	0.0	0
Cloth	72.1	131
Glass/Ceramic	1,702.1	3,489
Metal	915.3	2,216
Paper/Cardboard	0.02	2
Rubber	295.0	74
Wood	25.2	12
Other	11.5	11

TOTAL WEIGHT: 3,144.4 LBS
TOTAL COUNT: 6,522 ITEMS

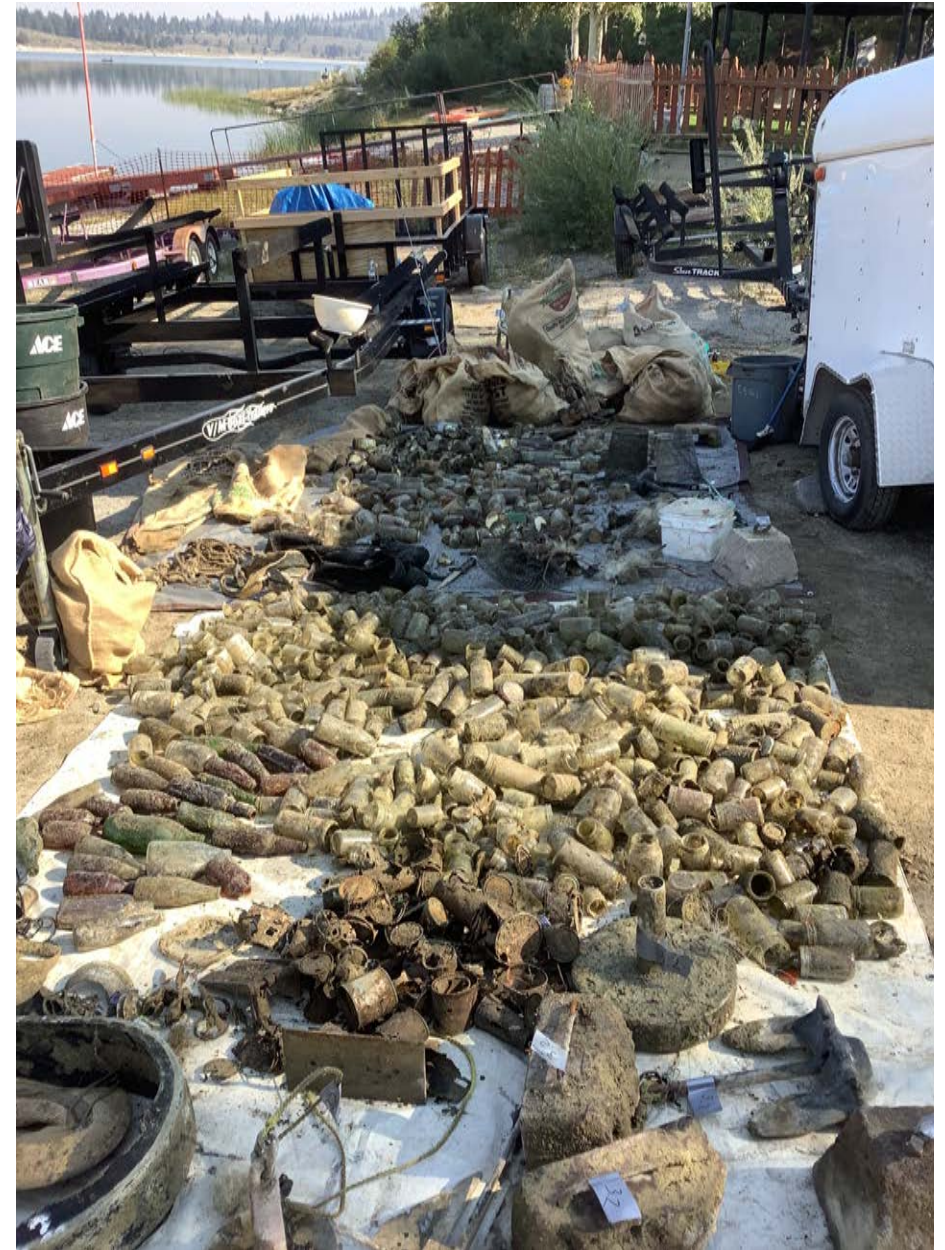
General Litter Items Found

- Most of the litter collected was glass, specifically **powerbait jars and mason jars**; with over 3,000 power-bait jars equaling 47% of the quantity of litter items found in June Lake.
- Outside of glass, there were numerous **beer cans** and dozens of **anchors**.
- Typically, we average 472 items per mile of clean up. For June Lake the concentration of litter was **2,518 pieces of litter per mile**, making it 5 times dirtier than lakes we have previously cleaned.

After circumnavigating the lake, the observations and data collected conclude that June Lake would benefit from further remediation work. CUTL recommends implementing further litter removal programs followed by lake monitoring, community awareness projects, educational programming, litter prevention signage and more.

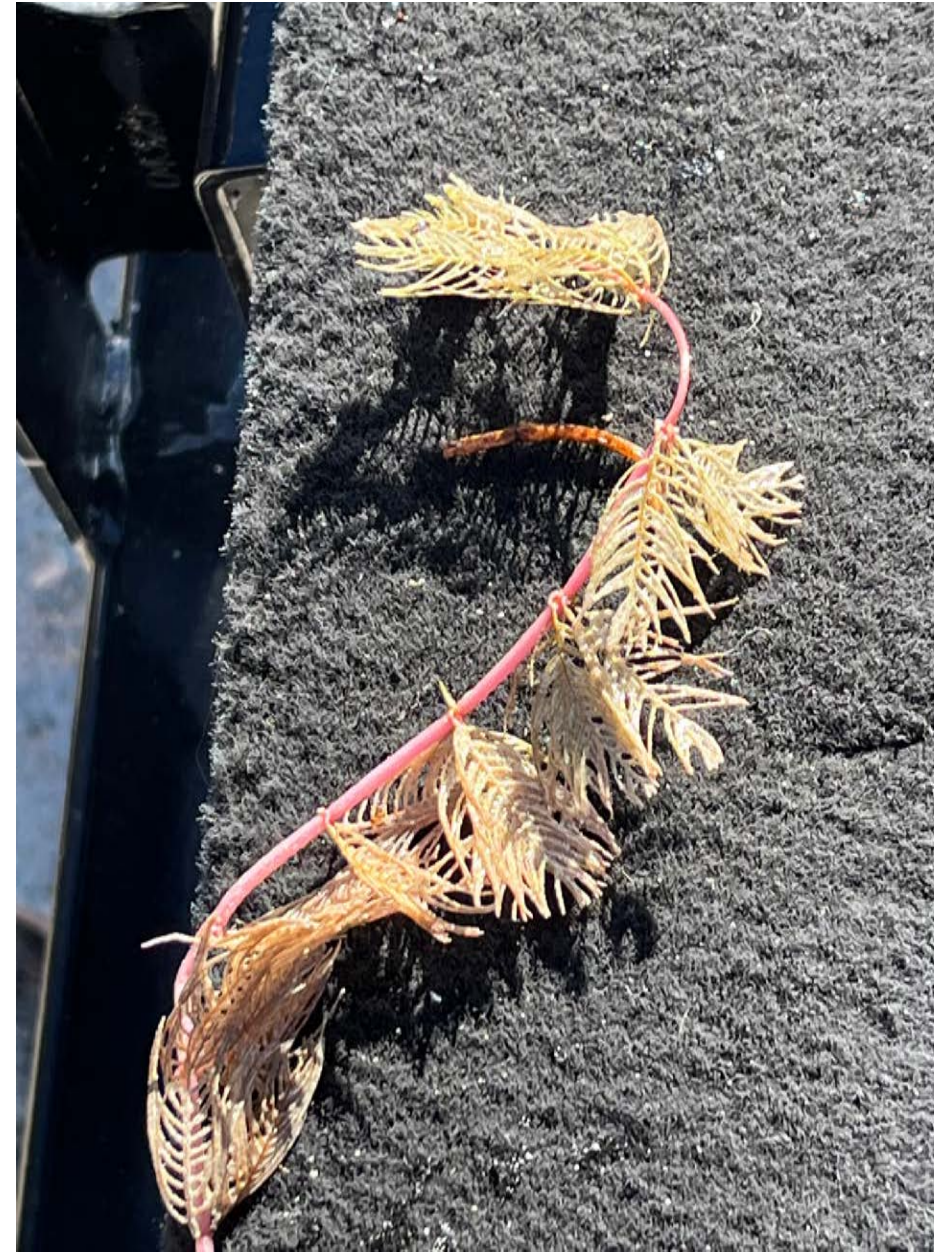
Vegetation and Possible Aquatic Invasive Species

- Minimal algae growth seen.
- There was significant vegetative growth in 3-10 ft of water. The photo to the right displays the only vegetation found around the lake. Our data's photo and video content is currently being sent off for analysis by contracting environmental scientists.

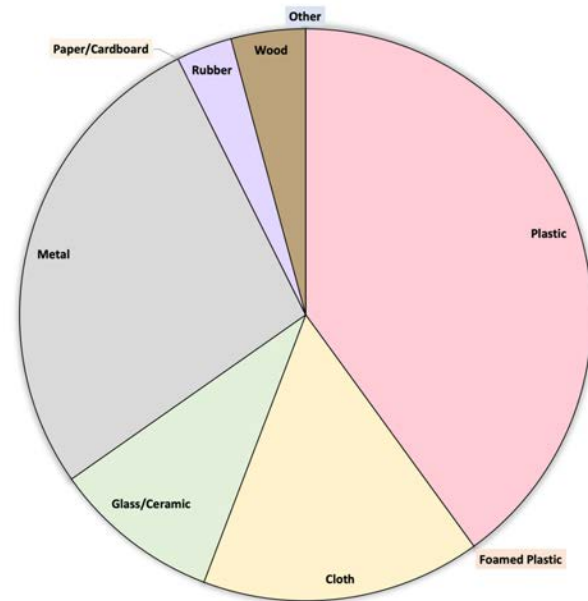
Litter Distribution

LITTER BY MATERIAL (WEIGHT)

LITTER BY MATERIAL (COUNT)

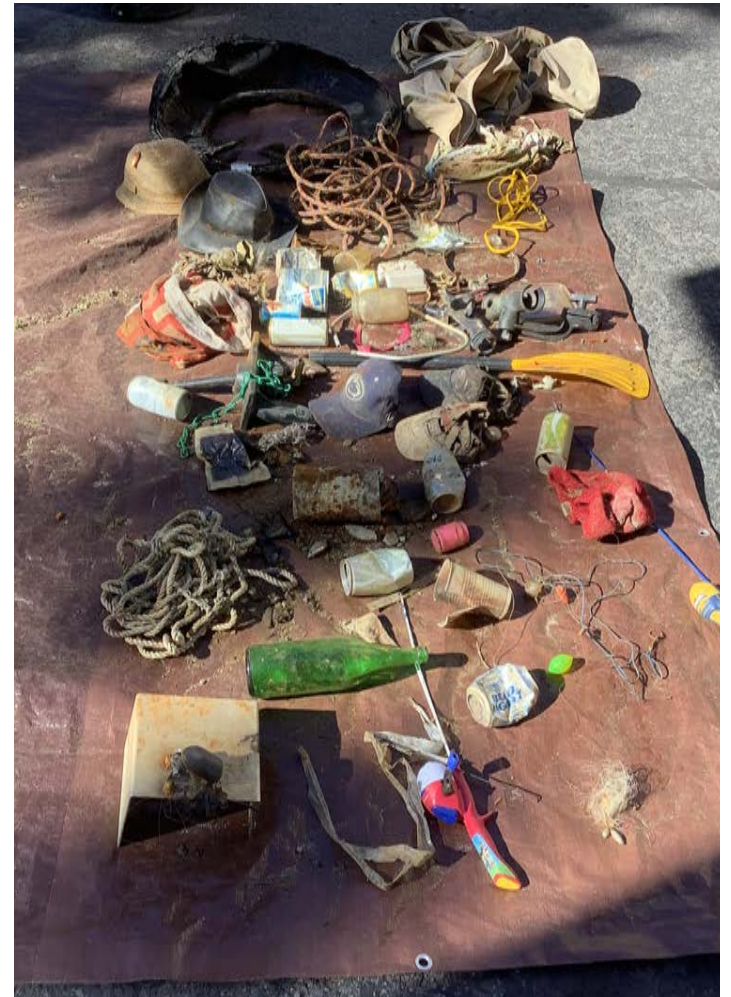
General Litter Items Found

- We collected an amount of litter **significant enough to warrant a circumnavigated clean up of the lake.**
- Litter primarily consisted of **beer cans, bottles, anchors, fishing poles, fishing line, lures, anchors, tires, etc.**

1. Lake Mary: A circumnavigational cleanup should be conducted in the early spring when the snow melts. This will ensure better clarity and lower levels of vegetation for divers and free divers to see and collect more litter than was visible in September '22.

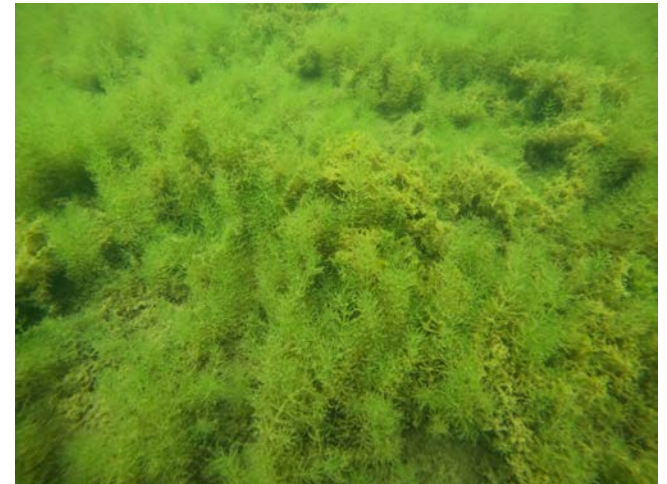
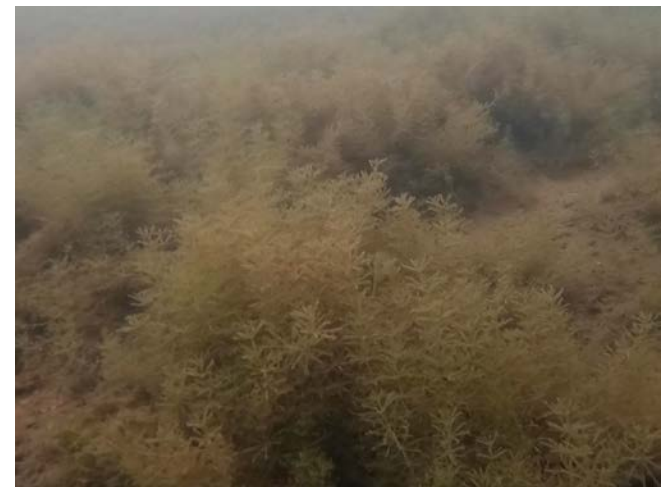
Vegetation and Possible Aquatic Invasive Species

- Poor visibility
- Several algal blooms present and recorded
- Significant vegetative growth as seen in the pictures to the right. Our photo and video data content is currently being sent off for analysis by contracting environmental scientists.

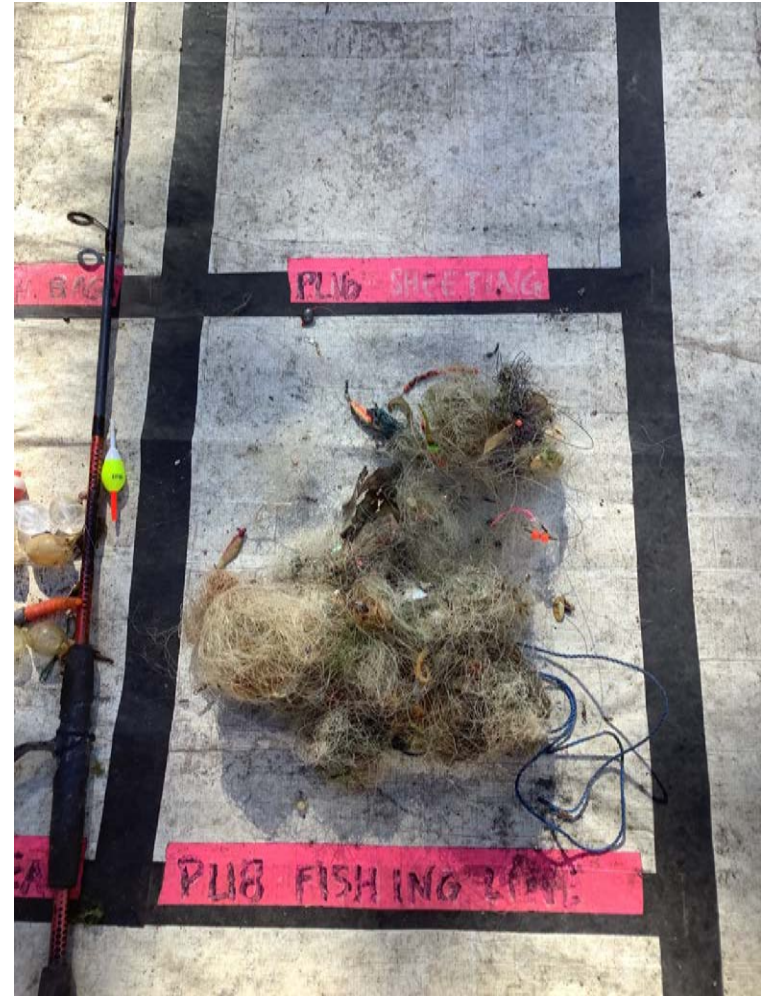
General Litter Items Found

- Predominant litter was **fishing line** and **lures**.
- Outside of fishing equipment, there were **anchors**, **beer cans**, and **plastic cups**.
- Additional tools would be needed to collect the egregious amount of fishing line present in the lake.

2. Lake George: A circumnavigational cleanup is recommended for Lake George. It would likely take longer due to the amount of fishing line in the lake and the additional tools that would be needed to remove all of it. The cleanup will be performed in late Summer/early Fall due to good water clarity.

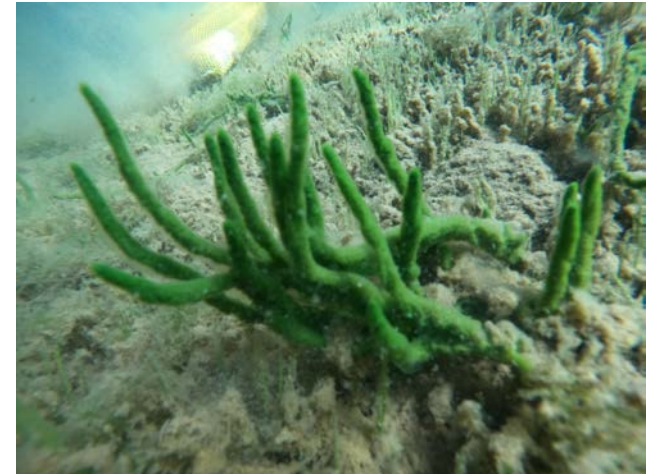
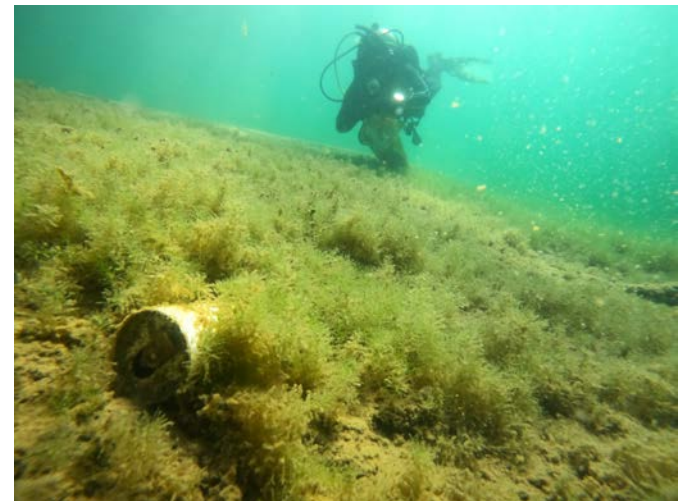
Vegetation and Possible Aquatic Invasive Species

- Good water clarity
- Minimal algal blooms were present and documented.
- Several different species of vegetation as seen to the right. The growth was not enough to hinder diving in the lake. Our data's photo and video content is currently being sent off for analysis by contracting environmental scientists.

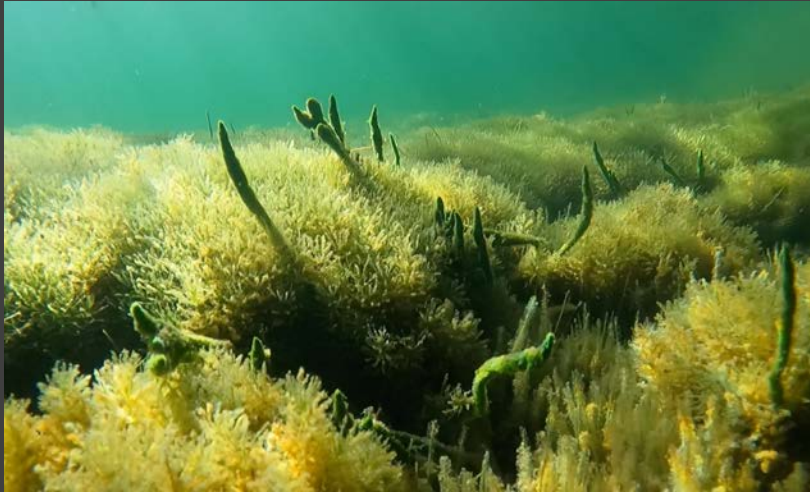
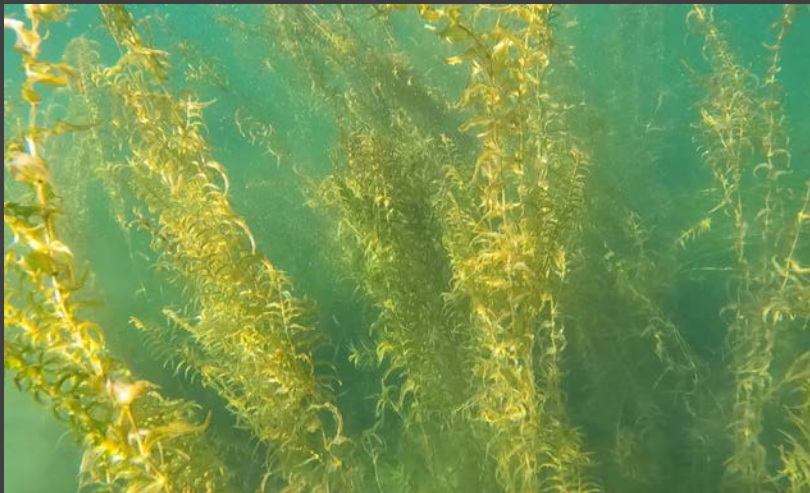
- Lake Mamie is shallow, about 8-10 feet, with good visibility.
- Minimal algae was found
- There was plant growth across the entire lakebed as seen to the left. Our data's photo and video content is currently being sent off for analysis by contracting environmental scientists.
- Lots of small litter items such as wrappers, degraded fishing equipment, and meso-plastics were found.

3. Lake Mamie: The shallow depth and amazing clarity make Lake Mamie a good candidate for a circumnavigational cleanup. This cleanup will likely be performed in FY24 to allow for the maturation of CUTL's AIS program, as it is an area of concern for Lake Mamie.

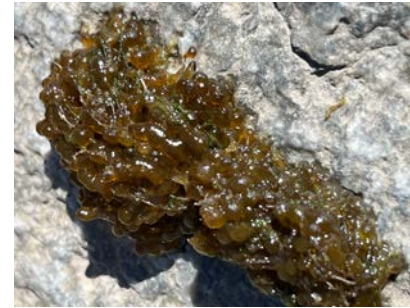
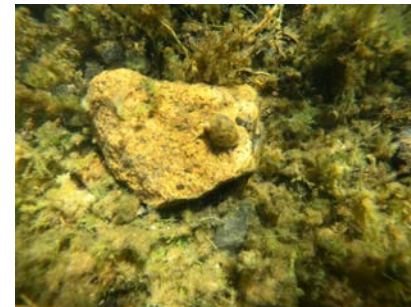
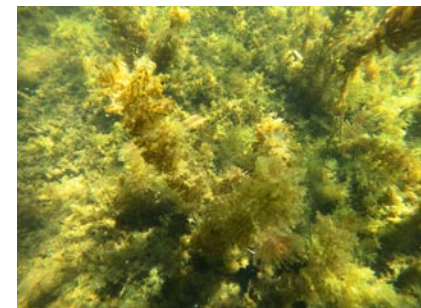
Vegetation and Possible Aquatic Invasive Species

- Strong presence of vegetative growth
- The lake was shallow and warm with significant algal blooms present.
- There were at least 2 if not 3 significantly present plant species as seen to the right. Our data's photo and video content is currently being sent off for analysis by contracting environmental scientists.

4. Twin Lakes: Vegetation was so strong here that scuba diving was not possible in late Summer and even free diving was difficult. Therefore, surveys need to be performed again immediately following the ice melting. We are waiting till FY24 when our AIS program will be more advanced since this lake needs stronger AIS remediation.
